# Facilitation Services to Support Municipal Facilities Projects

**DRAFT** January 2020

## Municipal Facility Locations

City of Waupun  
Dodge and Fond Du  
Lac Counties,  
Wisconsin

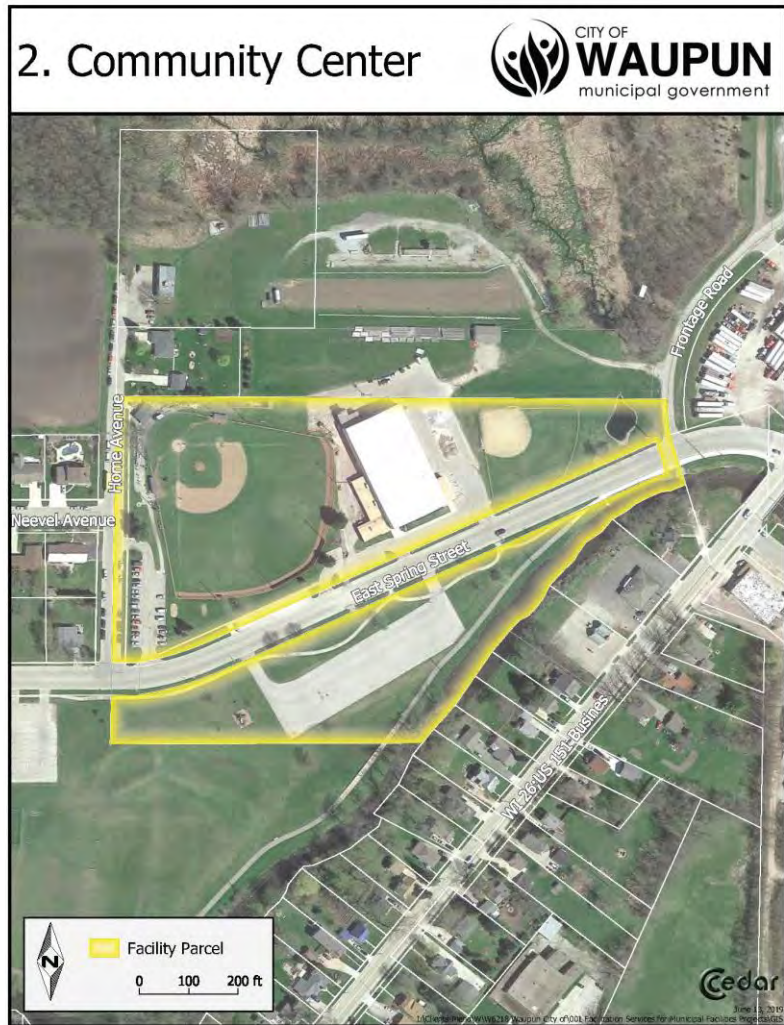
# Community Center – Hockey Arena

The Community Center was built in 1975 with an addition in 1995. The building is a metal building with some masonry exterior walls. Though the facility is named Community Center, it serves primarily as an indoor hockey arena. The Waupun Hockey Association operates the facility approximately 8 months out of the year. The Association is responsible for the hockey associated aspects of the facility, such as the refrigerated floor system and the Zamboni. In the off-season, the facility is used for other community activities such as the very successful annual Truck-n-Show and the Celebrate Waupun Festival. The large arena space is not air conditioned and not highly utilized in the off-season.

- The driveways and parking lot paving are in mixed condition. Some areas are newer and will require regular crack filling and sealcoating. Some are aged and, in time, will require replacement. Sealcoating, crack filling, and restriping are recommended every 4 years.
- The east parking lot surface drains have issues. Recommended alterations to improve the issues would be to incorporate internal storm drains.
- Site drainage around building should be improved

<b>Estimates of Probable Costs - Structure #2 – Community Center</b>	
Provide accessible entrance (allowance)	\$19,500
Seal coat parking lot (allowance)	\$19,500
Provide secondary exit (allowance)	\$6,500
Exterior Metal Painting (allowance)	\$54,600
Masonry wall repairs or recladding (allowance)	\$39,000
Update lobby and restrooms (allowance)	\$149,500
Provide ticket area at entrance (allowance)	\$6,500
Provide accessible seating at interior (allowance)	\$6,500
Renovate locker rooms / restroom / showers (allowance)	\$793,000
Add storage rooms (allowance)	\$71,500
Update vending area (allowance)	\$234,000
Roof replacement - allowance - roof 8-10 years old (allowance)	\$67,600
Update HVAC system except primary arena (allowance)	\$84,500
Updated HVAC arena (allowance)	\$280,800
Updated plumbing as part of previous noted renovations (allowance)	\$0
Fire suppression (allowance)	\$130,650
LED Lighting (allowance)	\$174,200

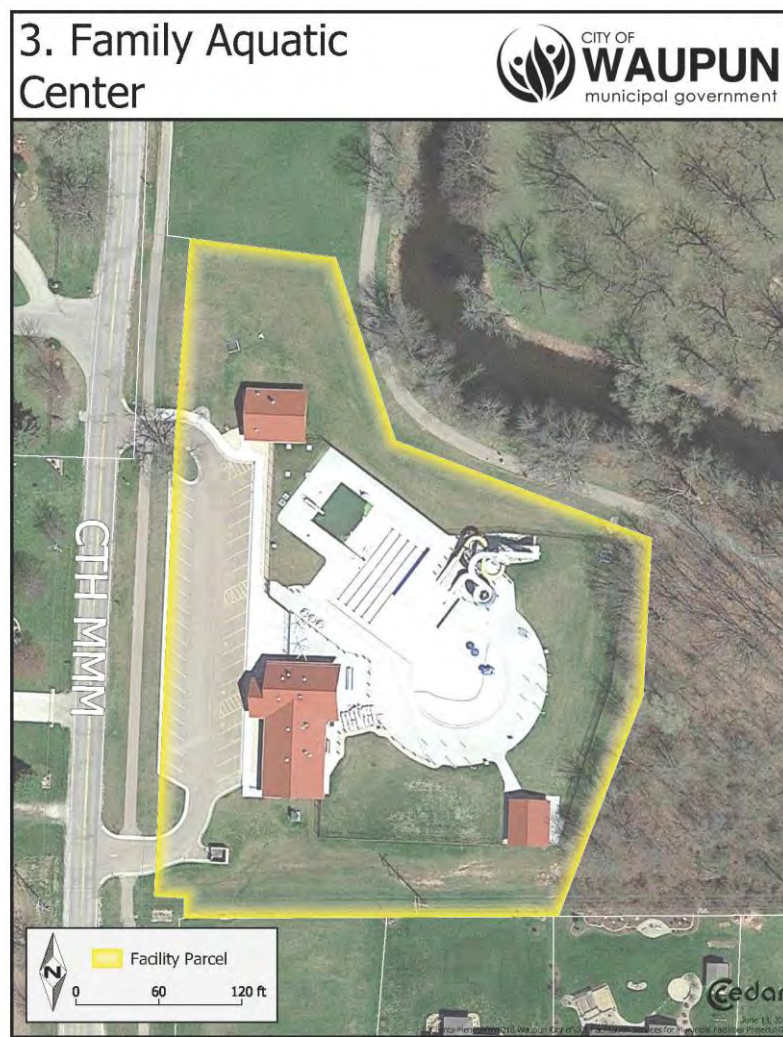
## FAMILY AQUATIC CENTER - 701 County Park Road

The outdoor aquatic facility features zero depth entry, two water slides, a kiddie slide, water geysers and fountains, a lap pool area, and two diving boards. The aquatic center is open seasonally and offers swim lessons, water aerobics, lap swim, swim team, open swim, and more.

- Consider ice/snow protection
- Add bird protection strips in open eaves
- Paint pool edge
- Consider fiberglass door at pump/chemical building
- Impellers (water pressure pump) wore out in 4 years; need to determine why and address issue
- There is no dedicated staff break room/area resulting in concessions area acting as staff break area. This creates a conflict with barefoot staff in the concession area; health and safety violation

<b>Estimates of Probable Costs - Structure #3 Aquatic Center</b>	
Climbing wall (allowance)	\$26,000
Paint pool basin with epoxy aggregate (allowance)	\$65,000
Bird protection (allowance)	\$2,875
Fiberglass door at chemical room (allowance)	\$5,750
Impellor maintenance (allowance)	\$0
Snow / ice protection (allowance)	\$3,450
Masonry screen wall cap maintenance (allowance)	\$920
HVAC commissioning to address temp control concerns (allowance)	\$13,650
Privacy slats in fencing allowance (allowance)	\$3,450
Replace with LED lighting (allowance)	\$19,320
<b>Total Estimated Costs for Proposed Improvement cost</b>	<b>\$140,415</b>

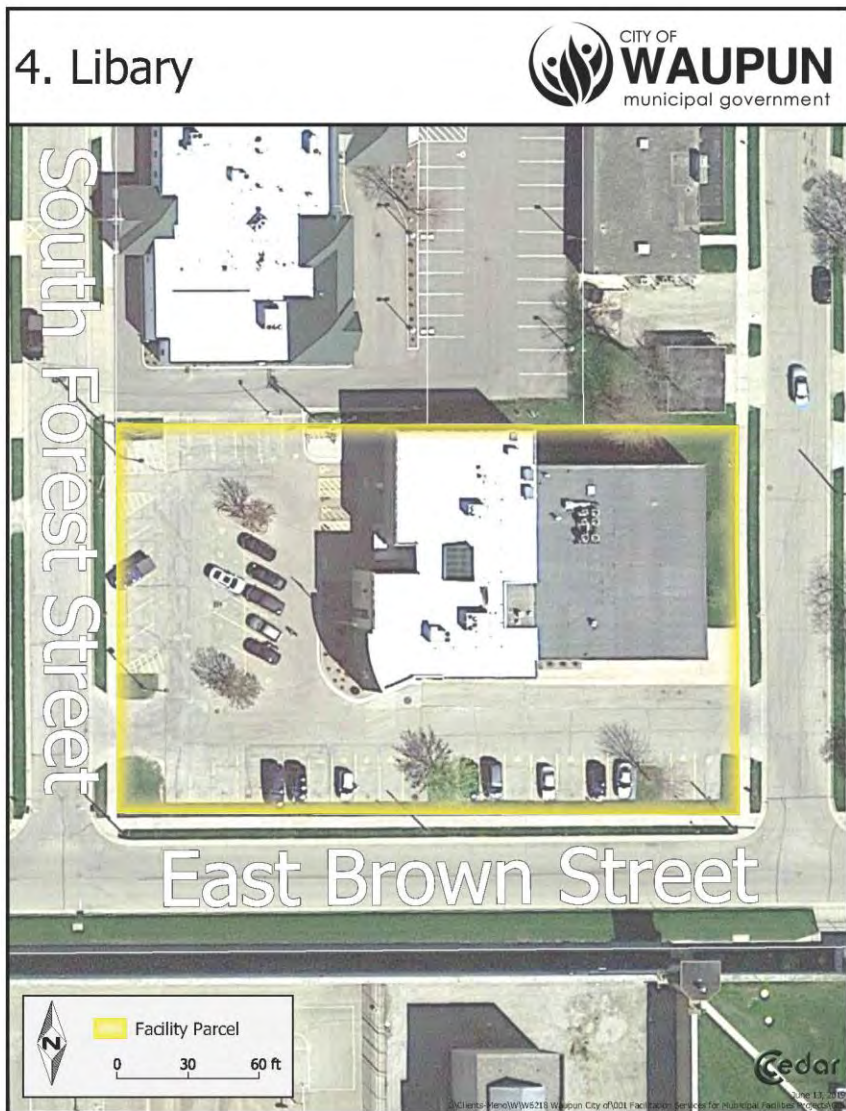
# Library Facility - 123 S. Forest Street

The facility was originally built in 1968 and has been expanded and remodeled in the past 10 years. The facility is well maintained and in good condition.

- Front entrance canopy and related drainage should be modified to minimize ice buildup and hazards
- Desire for additional green space
- Review options for additional parking
- Add car side book drop and pickup

- Security systems/monitoring are in place
- Roof was installed in 1997 and requires regular monitoring, maintenance, and eventually replacement
- HVAC system struggles during large events, and there are a few older furnaces; system should be upgraded
- Investigate window leaks and replace as needed
- Consider LED lighting throughout the facility
- Consider sensor faucets throughout the building
- General ongoing maintenance needed with the monitoring and replacement of sealant joints in the building
- The gas piping on the exterior is rusting and requires preparation and painting
- The exterior stone building veneer is soiled and dirty; cleaning is recommended
- Carpet replacement at the Children's area is needed soon.

<b>Estimates of Probable Costs - Structure #4 Library</b>	
Seal Parking lot	\$11,500
Add storm piping to building for front roof	\$6,500
Reconfigure front roof drainage	\$6,500
Roof replacement allowance -completed in 2016, renovation in 2009	\$62,400
HVAC improvements / replacements (4) units	\$69,000
Water heating	\$11,500
Elevator modernization	\$117,000
Building cleaning	\$1,725
Flooring replacements	\$82,800
Repair window leaks (allowance)	\$8,625
Replace to LED Lighting	\$55,200
Add sensor faucets	\$6,900
Car side book drop	\$4,025
Summer Program Space (HELD ELESWHERE)	\$0
Added exterior program space, acquisition cost UNKNOWN	\$0
<b>Total Estimated Cost for Proposed Improvement cost</b>	<b>\$443,675</b>

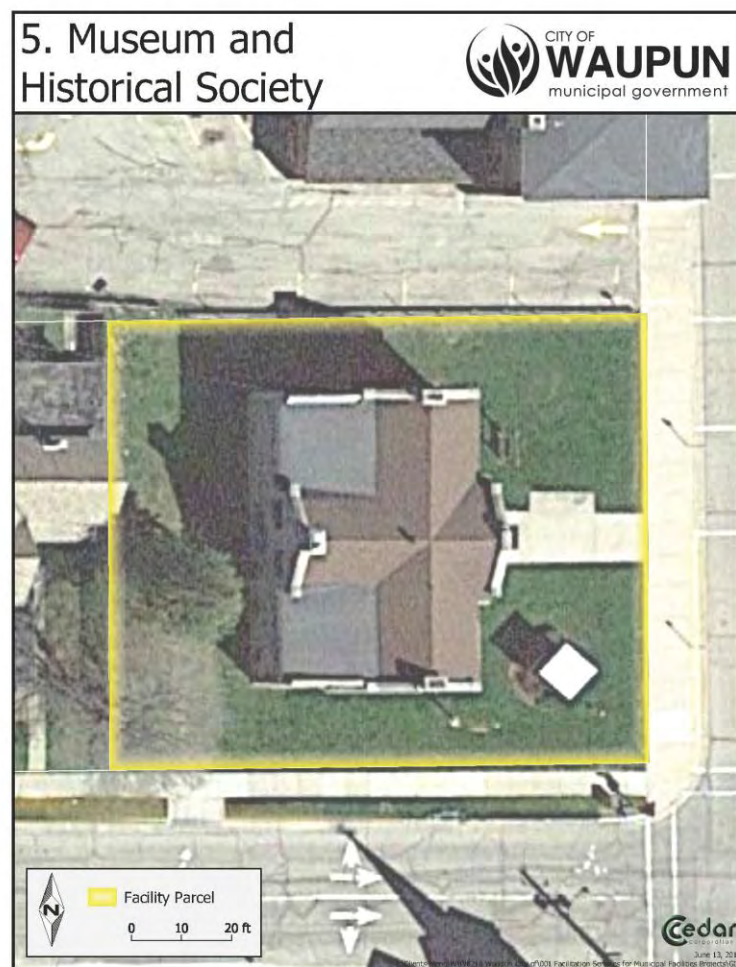
## Museum and Historical Society - 22 S. Madison Street

This building was constructed for the Waupun Public Library in 1905. This building is a Carnegie Library and is on the National Register of Historic Places as of September 4, 1979.

- Consider budgeting for HVAC replacements and/or maintenance
- Update electrical system
- Repair failing plaster in attic area
- Monitor humidity, moisture, ventilation in attic/stairway

- Consider minor tuck pointing
- Repair leak stains on ceiling and walls
- Review fireplace sealing
- Replace (missing) wall fixtures/lights at main entry to address moisture infiltration, energy efficiency, and better illumination of the facility

- Maintain doors and windows with putty filling and painting
- Areas above the main entry door transom windows and the round feature window above that have signs of water intrusion and deterioration, salt deposits, and cracked mortar joints. Repair masonry joints, stone, and flashing as needed to address the condition.

- Monitor drainage at rear door into basement which is recessed four steps below grade. The lower stair landing is cracked and requires replacement. A drain could be added to the area if desired to eliminate potential water into the basement.

- Prepare and paint the exposed overhanging roof sheathing boards at the north end of the west wall
- Prepare and paint the rusty west wall mounted air conditioning condenser racks

- Boiler is aged and requires monitoring and planning for future replacement

<b>Estimates of Probable Costs - Structure #5 Museum</b>	
Provide accessible parking and parking stalls	\$13,000
Regrade to improve drainage	\$6,500
Provide rain leader connection to storm piping	\$7,800
Provide drain at exterior entrance to basement	\$6,500
Allowance for minor tuckpointing	\$39,000
Maintenance to front sidewalk and stair allowance	\$1,622
Replace front lights	\$2,080
Roof Replacement Allowance	\$22,880
Provide 10-year allowance / yr. for window maintenance and replacement	\$70,200
Add attic ventilation	\$5,720
Repair attic stair plaster	\$13,000
Seal fireplaces	\$5,850
Allowance for future HVAC system maintenance	\$78,000
Add dehumidification	\$41,600
Plumbing fixture / water heater 5 yr. maintenance allowance	\$7,800
Allowance for electrical distribution	\$57,200
Allowance for lighting updates	\$34,320
Future addition for lift and accessible restrooms	\$274,950
<b>Total Estimated Cost for Proposed Improvement cost</b>	<b>\$688,022</b>

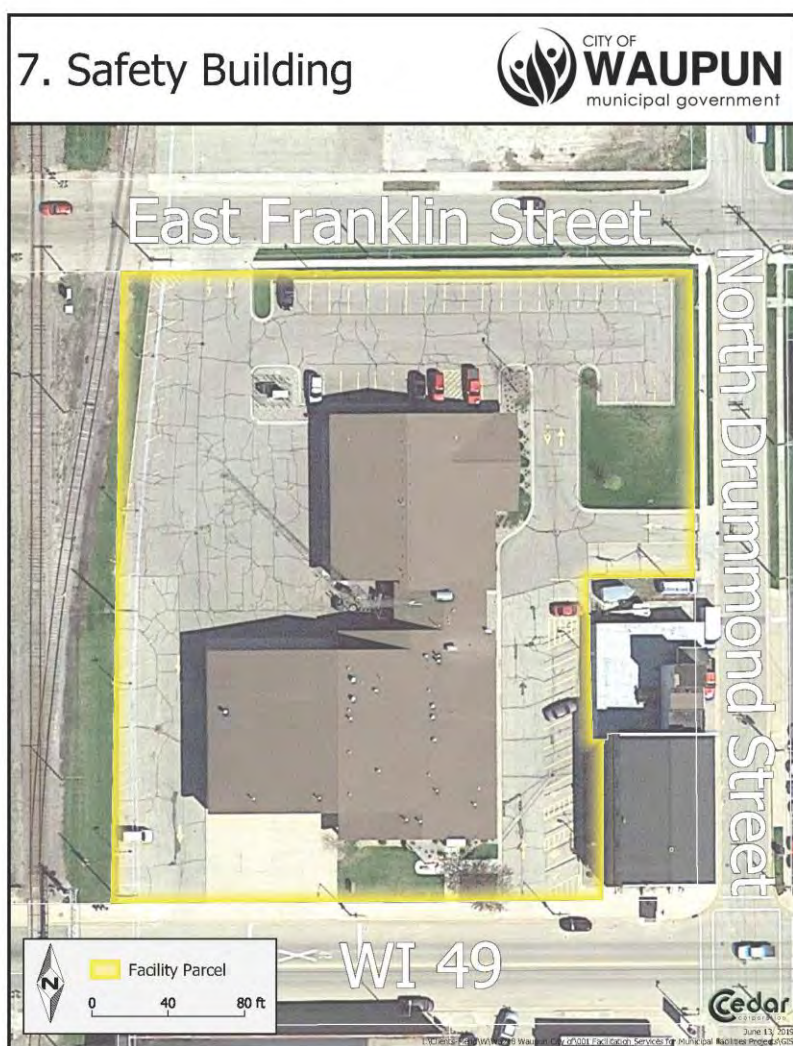
## Public Safety (Fire and Police) Facility - 16 E. Main Street

The facility is in good condition and has seen recent expansion. It is expected the facility will serve the community for some time to come. The building design is conducive to limited expansion. However, the site accommodations are limited since the facility takes up most of the block. The Police and Fire Department occupy the facility in separate portions of the main floor and basement. They do share access to the basement and some shared areas for training and fitness.

- A few sections of curb are cracked/chipped and require repair.
- The driveways and parking lot paving have some cracking and will require regular crack filling and sealcoating. Sealcoating, crack filling, and restriping is recommended every 4 years.
- Review location of grade at building
- Access and response and vehicle movements at rear of building area challenging

- Provide day room for firefighters
- Provide space for hazmat trailer, spill trailer, and command center (chief rig)
- Dedicated men and women locker rooms are needed with safes for personal belongings for fire department
- Provide dedicated shower/decontamination and laundry facility space to contain potential hazardous materials
- Provide clearance and protection at turnout gear space
- A fire bay expansion should be planned as equipment/vehicles currently fill all the bays and are triple stacked in some cases leaving no room for the EMS trailer and spill trailer that are currently stored offsite.
- The existing 12 ft. high doors are an ongoing limitation to equipment, such as the ladder truck; 14 ft. is the recommended garage door height

- Elevator should be retrofitted with compliant guardrail
- Review accessible parking
- Provide accessible restrooms
- Update entrances with auto operators and address front concrete slab
- Replace door hardware to meet ADA requirements

Add fire apparatus bay with decontamination	\$246,400
Add space for hazmat trailer, spill trailer, chief & run vehicle / added height for ladder truck	\$122,000
Renovate existing fire station	\$69,000
Renovate Fire Dept Apparatus Bay HVAC	\$44,000
Add vehicle exhaust	\$75,000
Provide police decontamination shower	\$21,500
Minor repairs in police evidence	\$5,000
Update exhaust in police evidence	\$5,000
Break room for Police renovation of existing space	\$31,150
Sally port modifications & addition - resulted from fire modifications	\$237,510
Laundry area renovation in existing garage bay	\$30,375
Hot water maintenance	\$10,000
Add bullet resistant glazing at police	\$10,000
Shooting range improvements allowance	\$19,500
Shower exhaust improvements	\$12,000
Add vehicle exhaust system	\$20,000
<b>Total Estimated Cost for Proposed Improvement cost</b>	<b>\$2,884,035</b>
